## APPLICATION OF INTEGRATED ENVIRONMENTAL MANAGEMENT MODEL ON ONE OF EGYPTIAN HOSPITALS

EL NADI, M. H.& YOUSSEF, I. M

Accordingly, inspection has been performed on one of governmental hospitals which has opened partially year 2008 then completed on 2013 and it has 300 beds with an overall built-up area exceeding 28,000 m<sup>2</sup> comprising 11 floors.

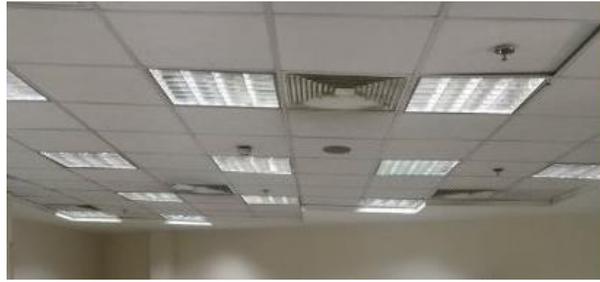
**Figure 4: Existed Ceiling System**

The following figures are showing the existing ceiling condition;

Replace broken gypsum false ceiling tiles as appeared below in figure (4).

Fix loose false ceiling tiles.

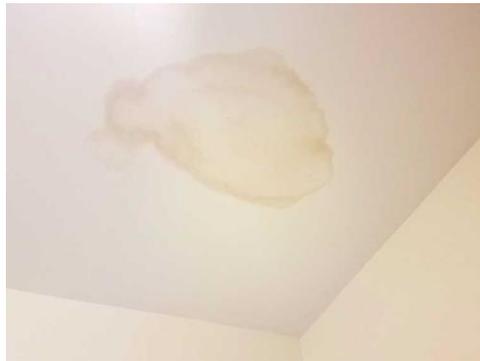
**Figure 5: Damped Ceiling Spots**

In ceilings with damp or wet spots – in wet areas – as shown in figure (5).

For exposed ceiling rooms with cracks in the cement plaster.

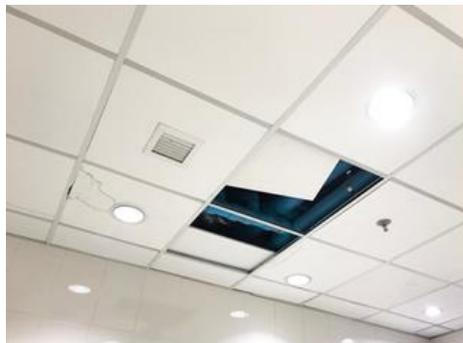
**Figure 6: Existed Ceiling tiles**

Some of gypsum ceiling tiles as appeared damaged below in figure (6) noting that acoustic performance is required to comply with noise levels especially in patient rooms as per the World Health Organization guidelines of 35 dB during the day and 30 dB at night.

Use ceiling materials with low VOC or zero emissions; such acrylic paint, plastic, metal, and mineral or glass fibres.

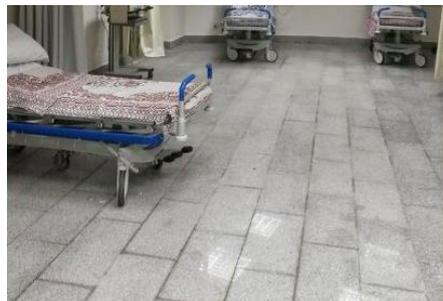
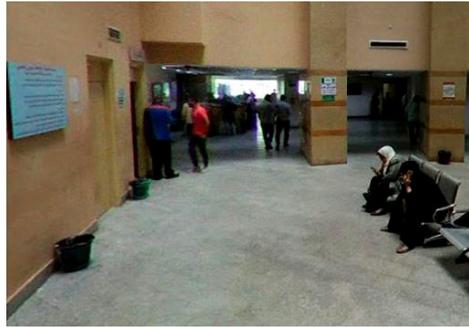
**Figure 8: Stone Flooring in Patient Rooms**

**Figure 9: Stone Flooring in Public Areas**

Generally, stone flooring is requiring filling joints as shown in figure (8) and figure (9) with grout and preferable to be epoxy based grout to provide more durability and higher sealing properties.

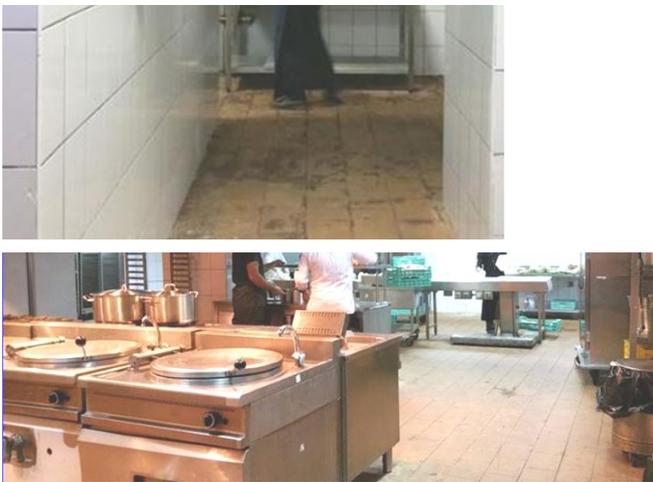
**Figure 10: Kitchen flooring**

Heavy duty Sornaga tiles in kitchen areas as shown in figure (10) are broken and their joints are mostly free from grout.

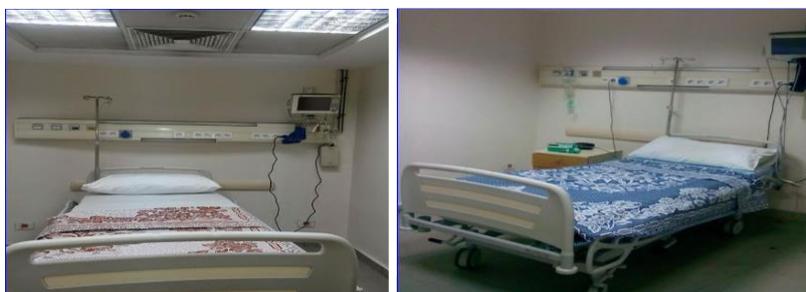
**Figure 11: Patients' Rooms**

For patients' rooms, the main colour selection was pale as appeared in figure (11) and depends on white, grey or beige colours and such colours will affect the psychological status, thus, the colour selections should reconsider this important issue.

The use of colour is used to serve as a wayfinding device for general use or for specific user profiles.

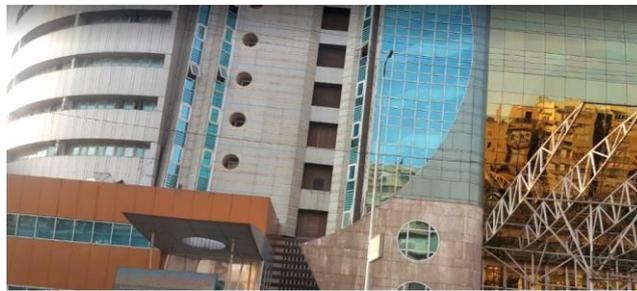
**Figure 12: Architecture-Exterior.**

environmentally 53% which is illustrated in Figure (12) reflecting a medium value that is due to the following;

Orientation of the building resulting in one of the longer sides being subject to sun heat (South- West).

Large areas are clad with structural glazing system which allows large amount of heat to transfer inside the building.

Few sun shading elements are used.

Heavy elements such as precast concrete panels are used.

No energy generating panels are used such as photovoltaic panels.

Some cracks require attention.

No green roofs are allocated.

No acoustic materials are used to lower the noise from the surroundings.
